System	Date of Issue	Bulletin Number	Bulletin Type
Odyne System G2V2	2/4/15 Rev. 10/6/15	00020	<input type="checkbox"/> Field Service Action <input checked="" type="checkbox"/> Technical Service Bulletin <input type="checkbox"/> Technical Service Advisory

Title: Elimination of AC Connectors J29a and J29b

Issue: Water intrusion in AC connector potentially causing fault codes 233, 150, 149 and 126.

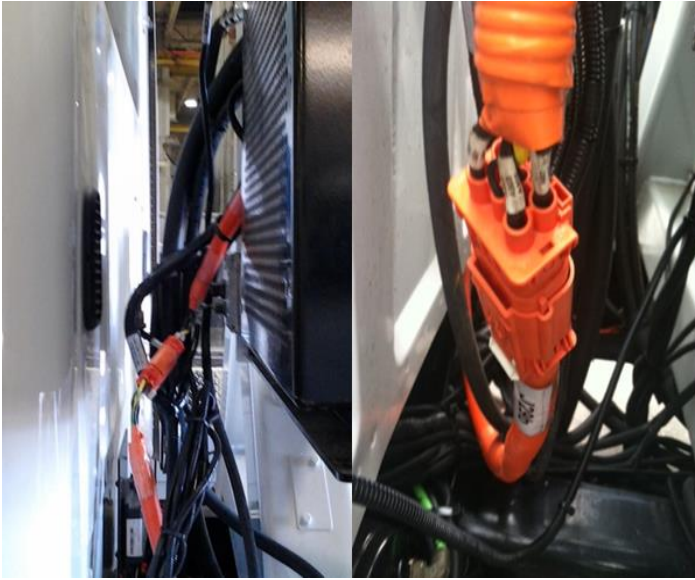
1. Locate AC connector J29A and J29B behind the cab.
