System	Date of Issue	Bulletin Number	Bulletin Type
G2V2	1/21/16	00023	<input type="checkbox"/> Field Service Action <input checked="" type="checkbox"/> Technical Service Bulletin <input type="checkbox"/> Technical Service Advisory

Title: ESPAR Cab Heater J28b Connector Wiring

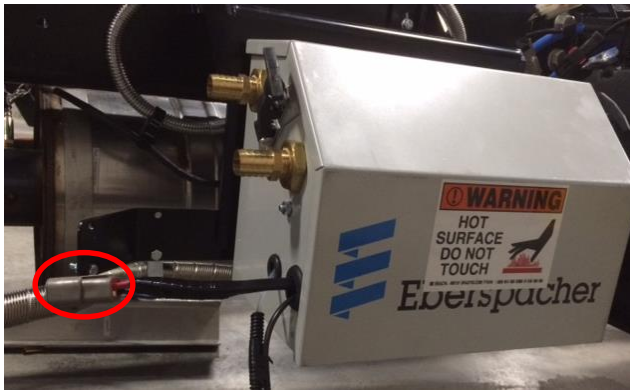
ESPAR Heater Connector/ J28b Harness Connector

Issue: Incorrect wiring at J28b connector causes ESPAR cab heater to not function.

3. Disassemble the heater side connector (male pin terminals). Use need-nose pliers to remove the wedge lock from center of connector body (orange).
4. Swap Pin 1 with Pin 3.
5. Assemble the J28b connector. Reinstall the orange wedge lock.
6. Reconnect the J28b connector.
7. Test the heater by placing the vehicle in ePTO mode and turning on the heater switch on the hybrid switch pack.
